Debris/Ice/TPS Assessment And Photographic Analysis For Shuttle Mission STS-48

November 1991

Gregory N. Katnik
NASA/Kennedy Space Center

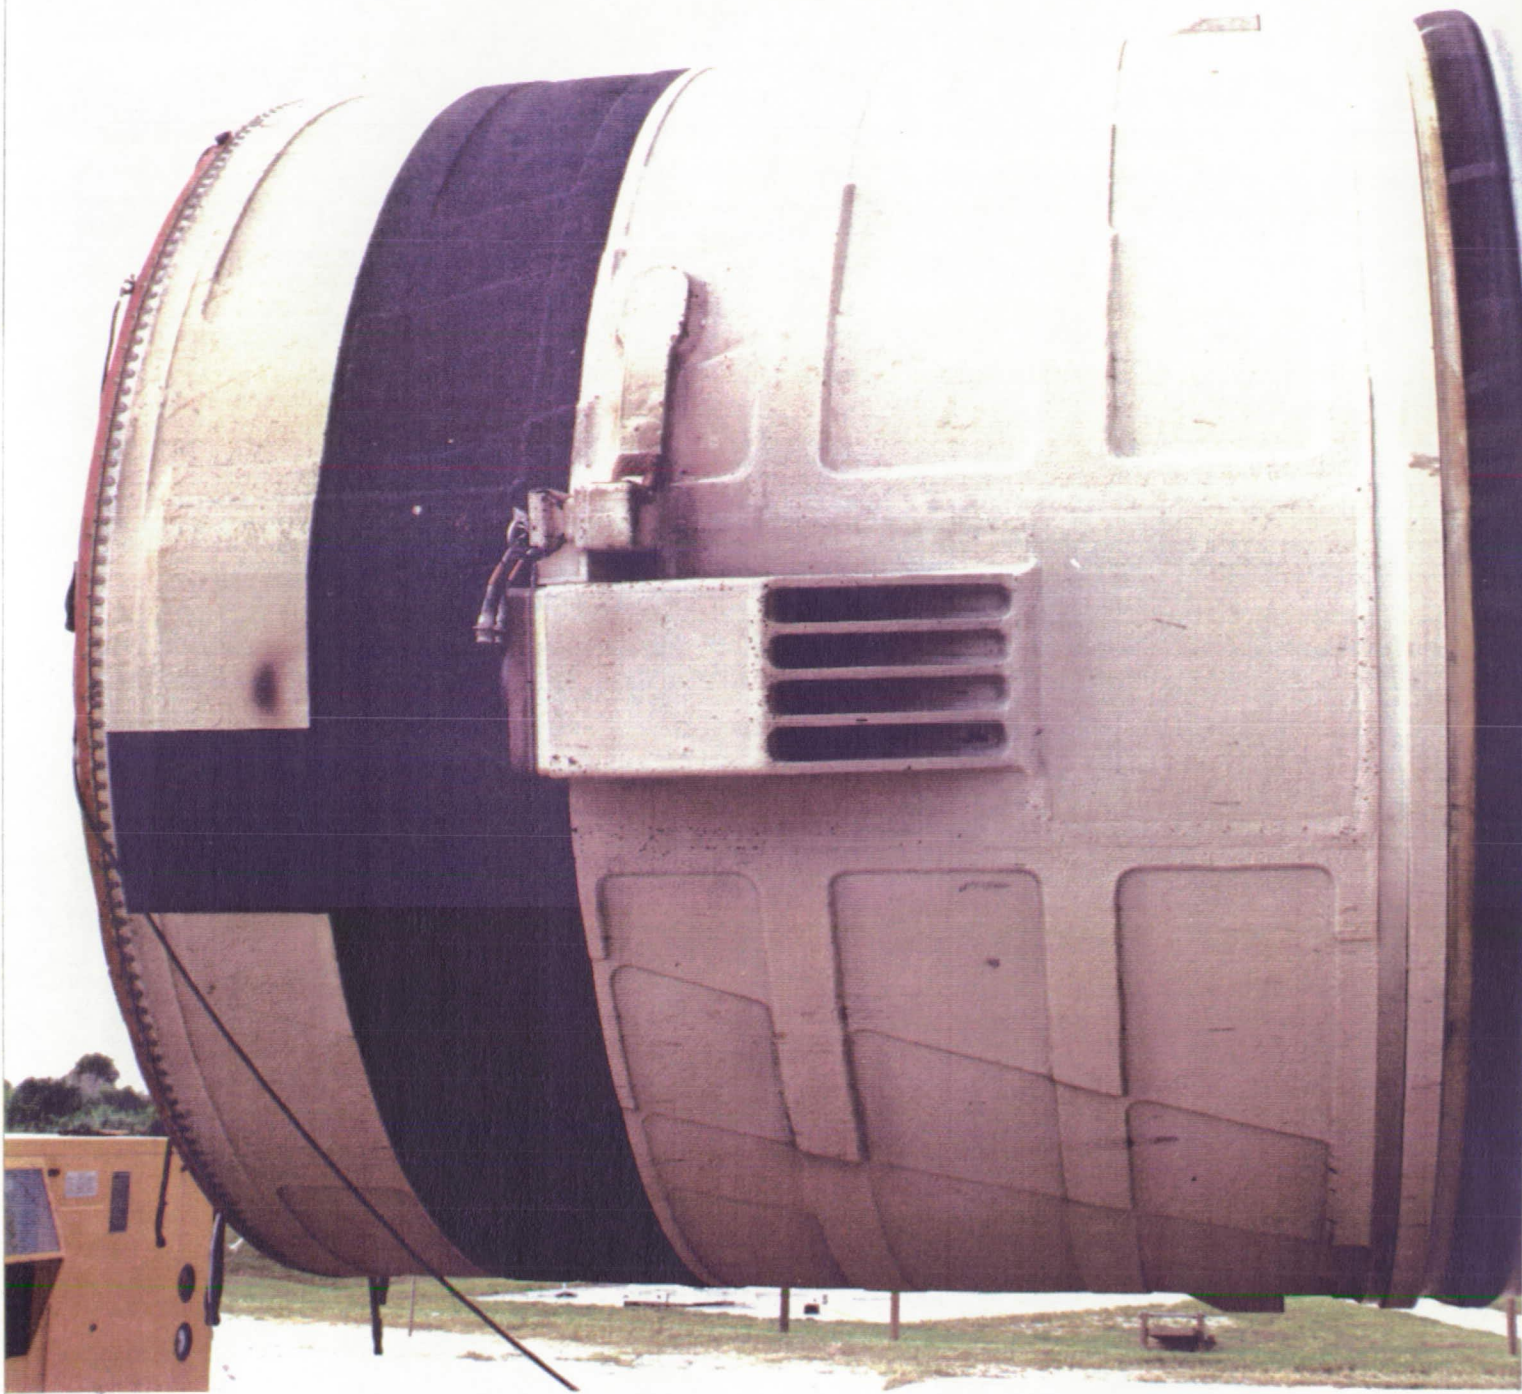
The left forward skirt exhibited no MSA-2 debonds. Minor blistering of Hypalon paint occurred forward of the ET/SRB attach point. The RSS antenna phenolic plates were intact.

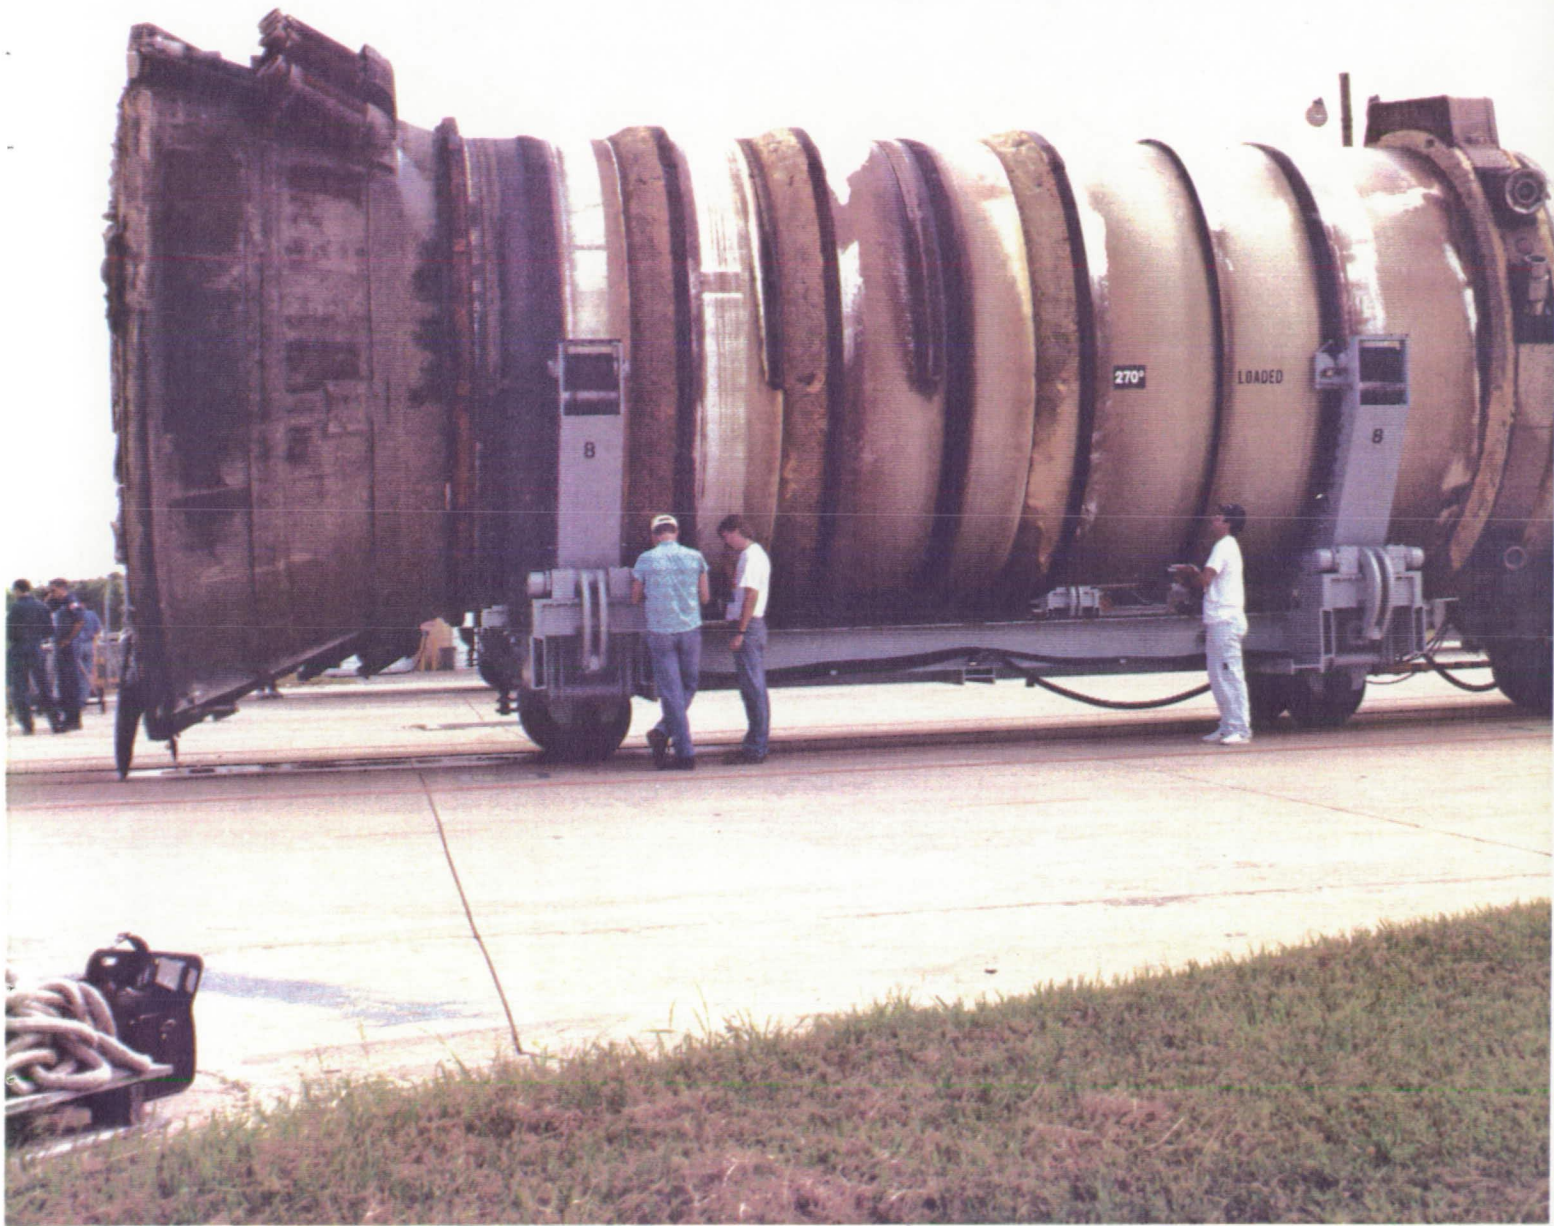
Post flight condition of the LH aft booster/aft skirt. The aft skirt acreage TPS was sooted but generally in good condition

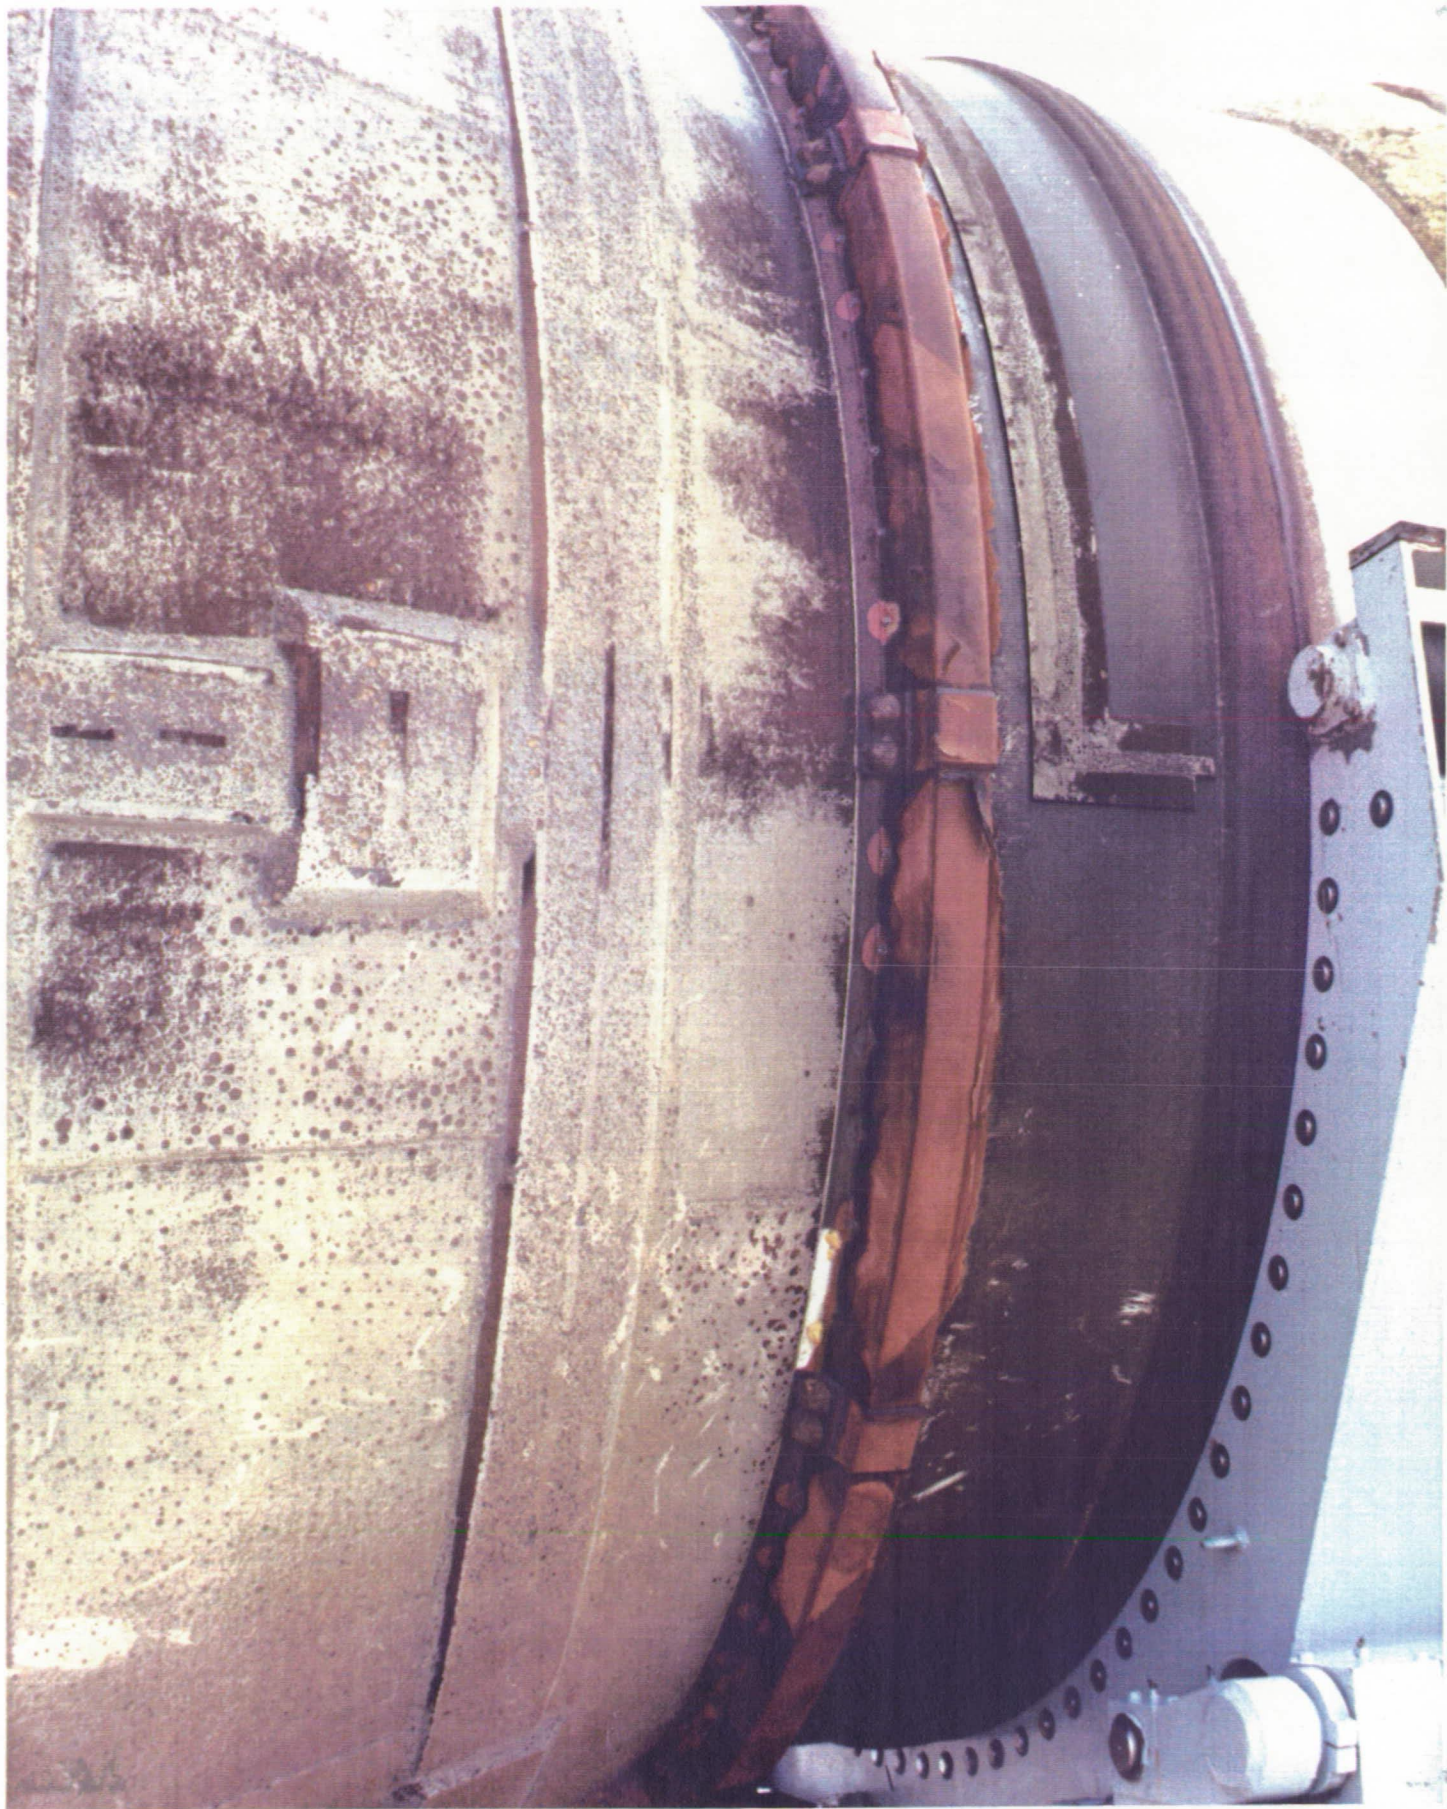
K5NA protective domes were missing from bolt heads on the phenolic kick ring prior to water impact. The substrate under the missing domes was sooted.

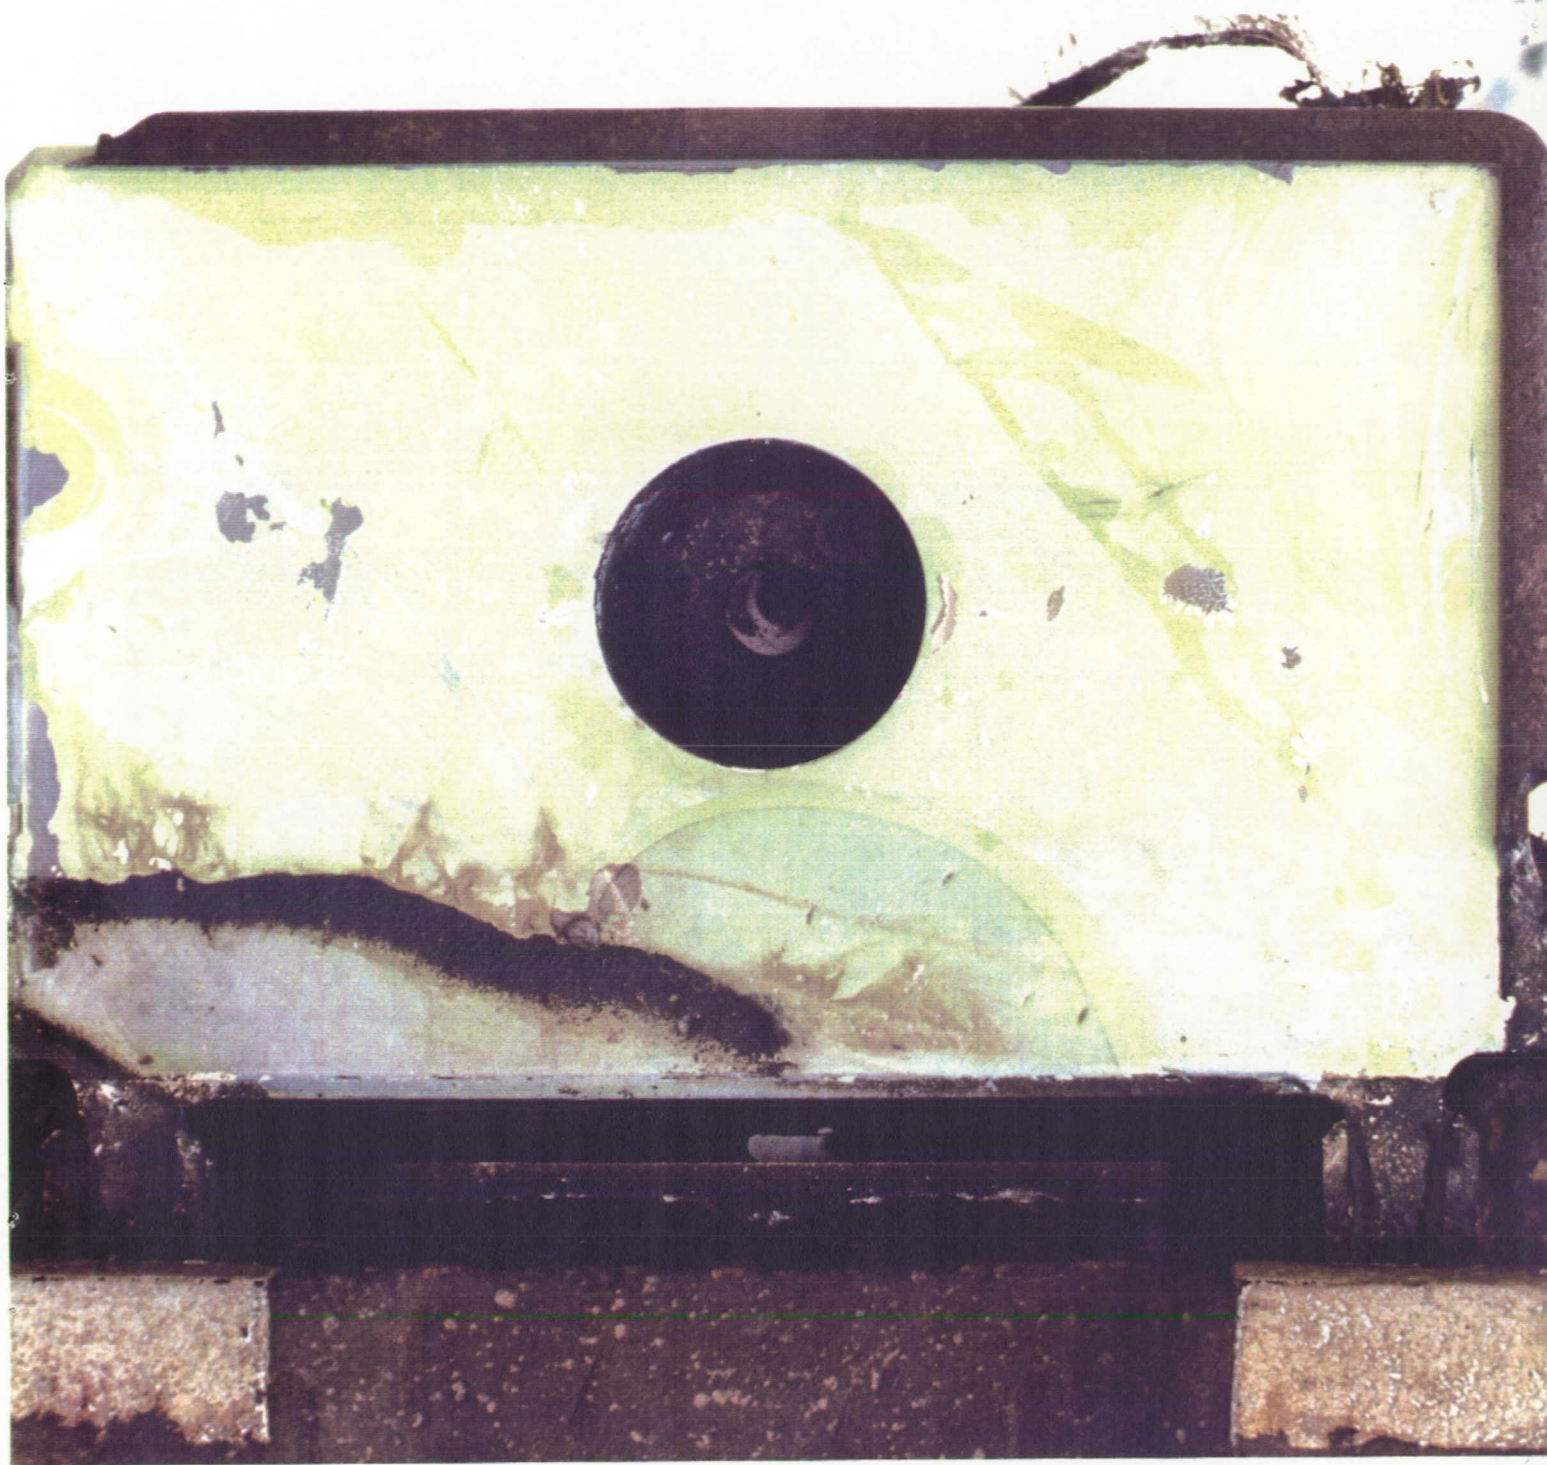
Aft skirt foot (sooted substrate) reveals part of the EPON shim material was missing prior to water impact.

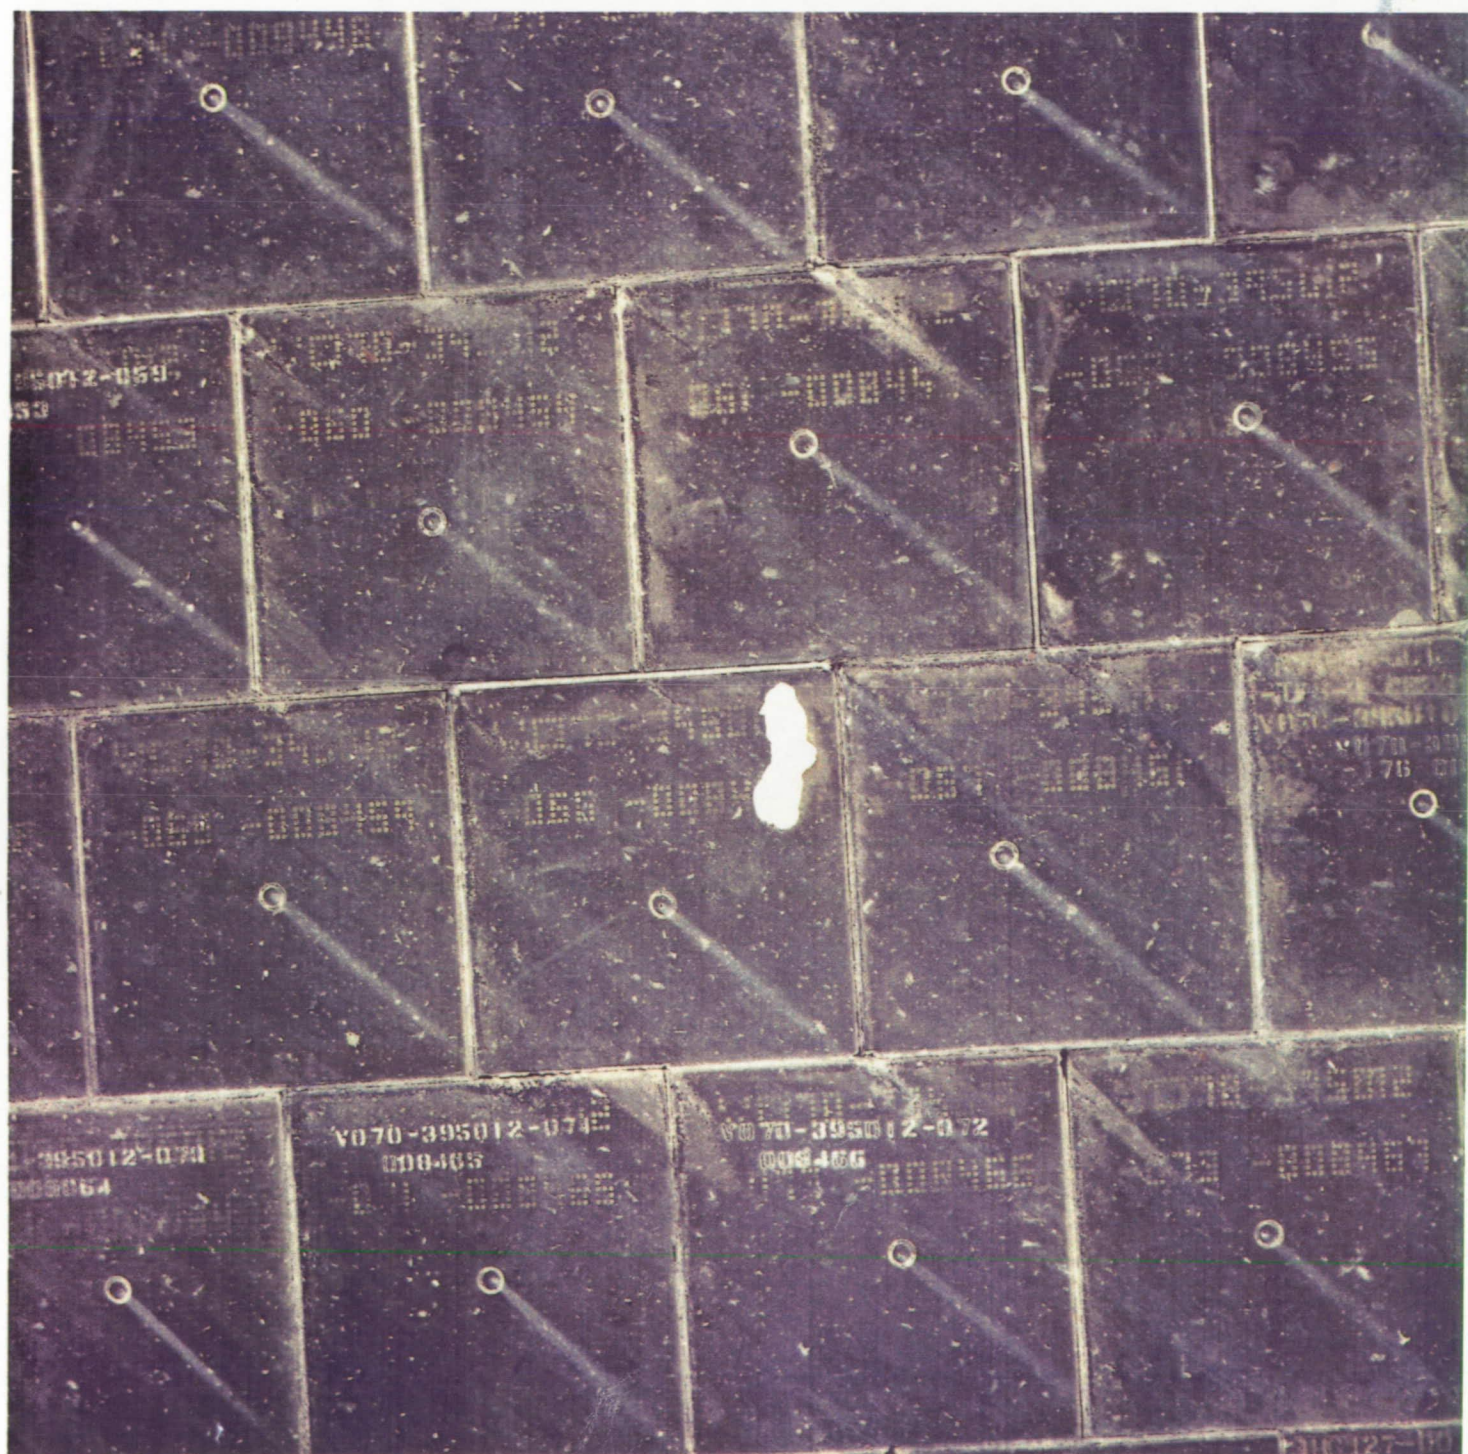
Typical tile damage on the Orbiter lower surface

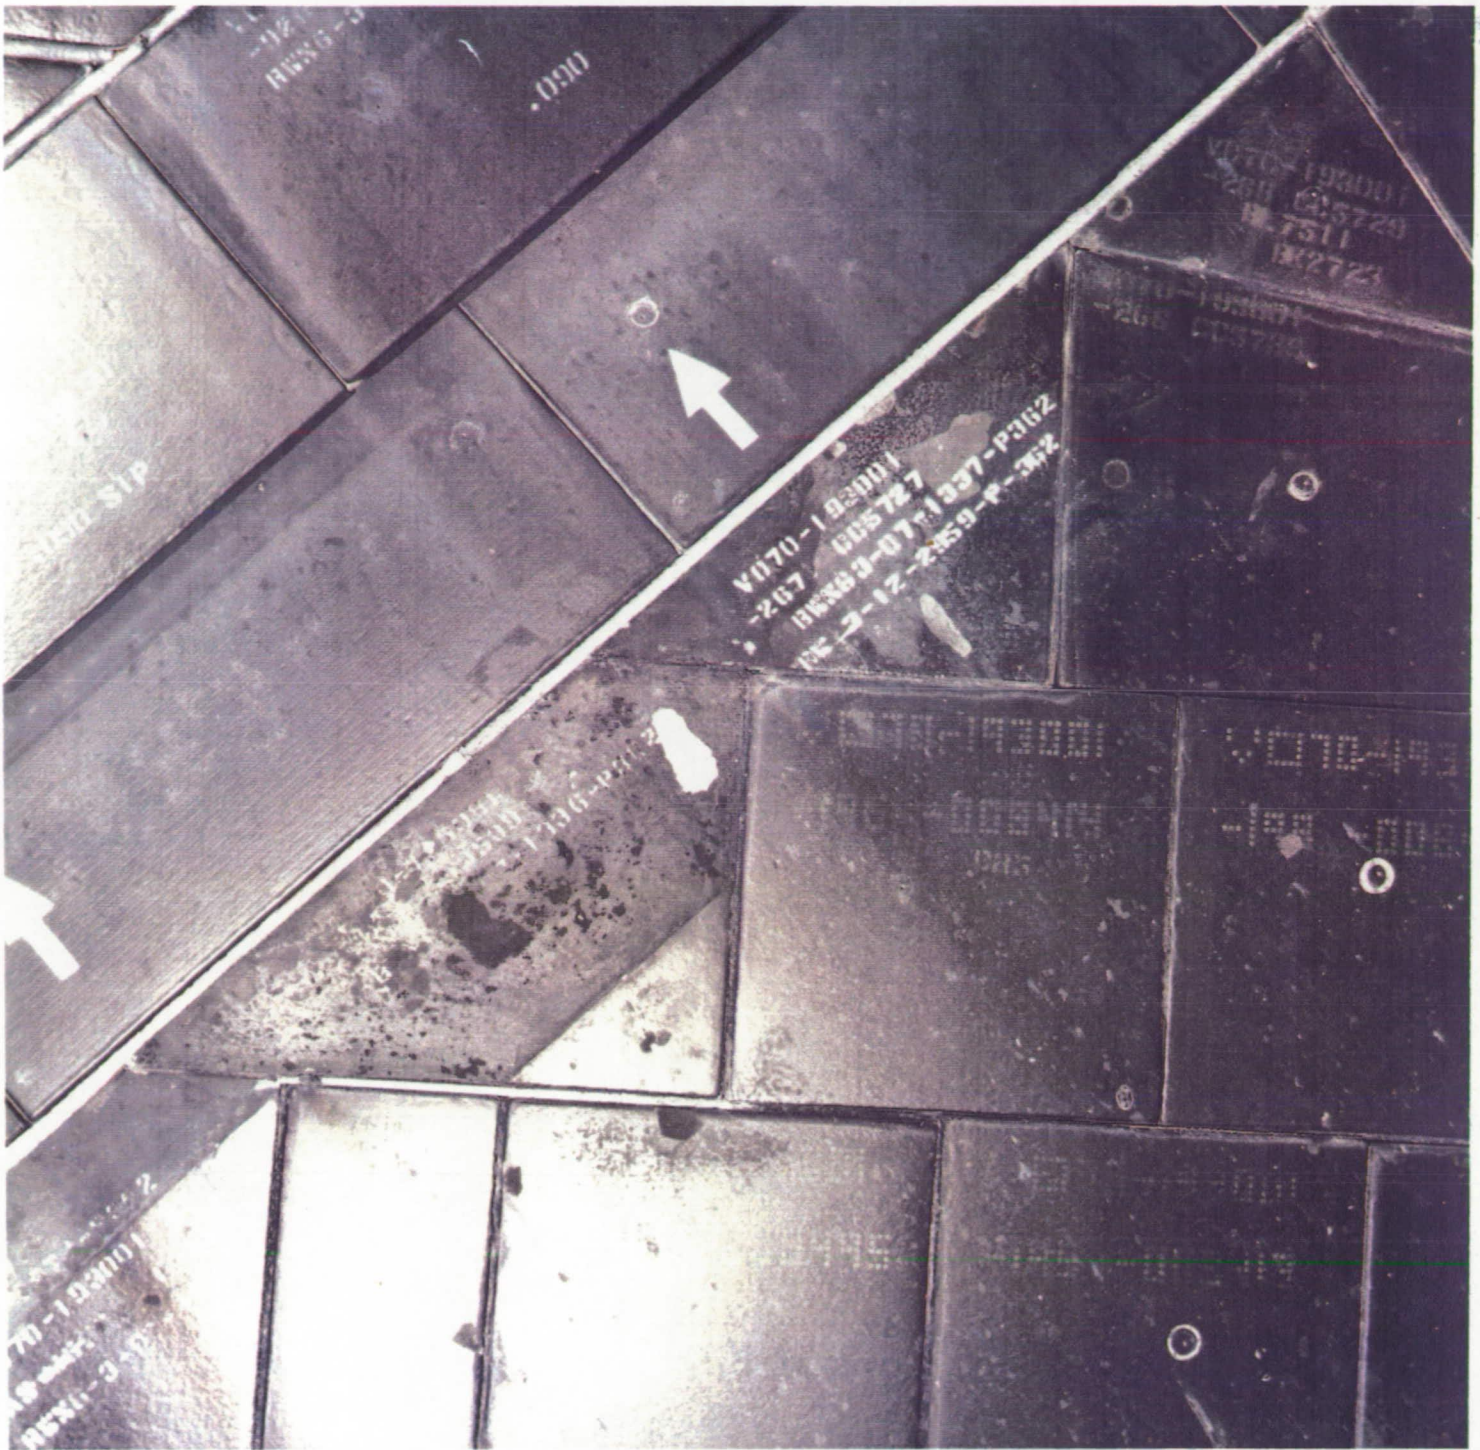
Typical tile damage on the Orbiter lower surface

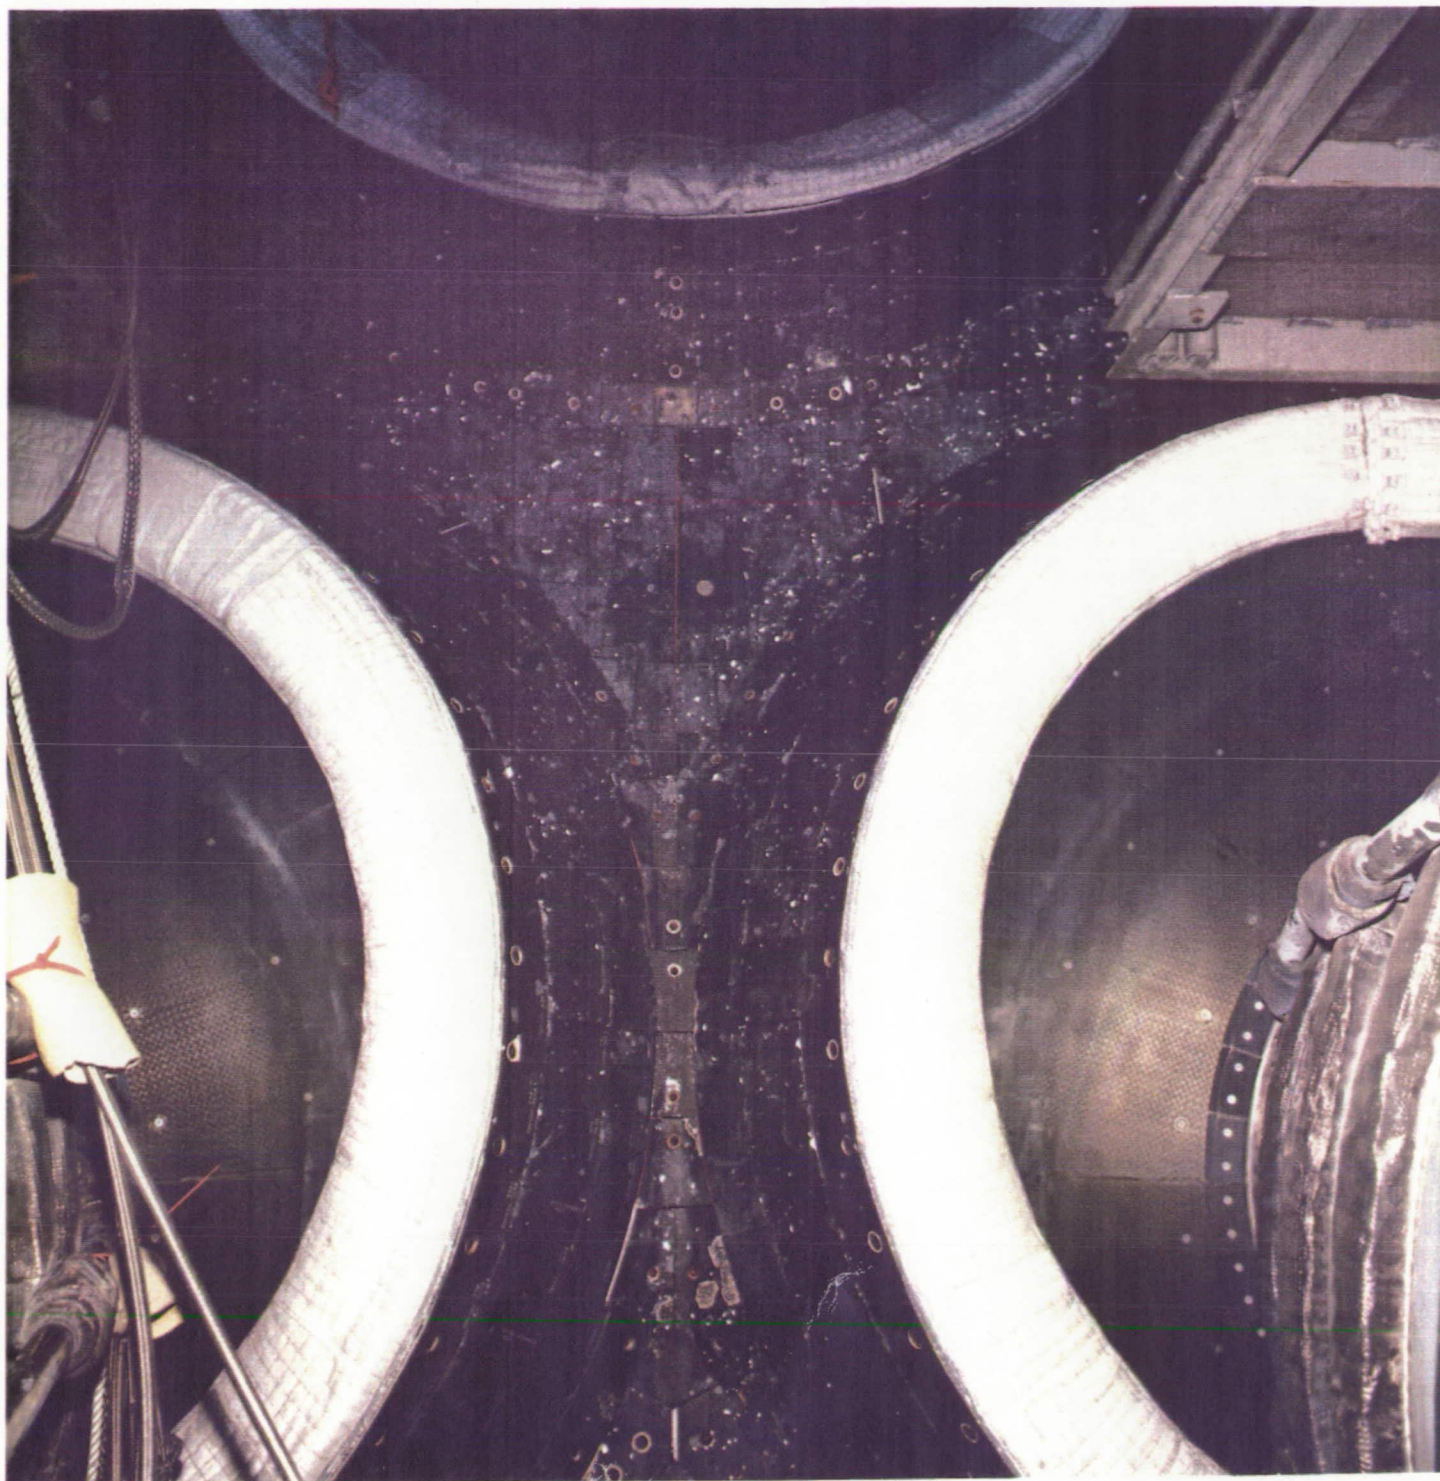
Damage to the base heat shield tiles was less than average. The main engine closeout blankets were in excellent condition with only minor fraying damage on the SSME #1 blanket.

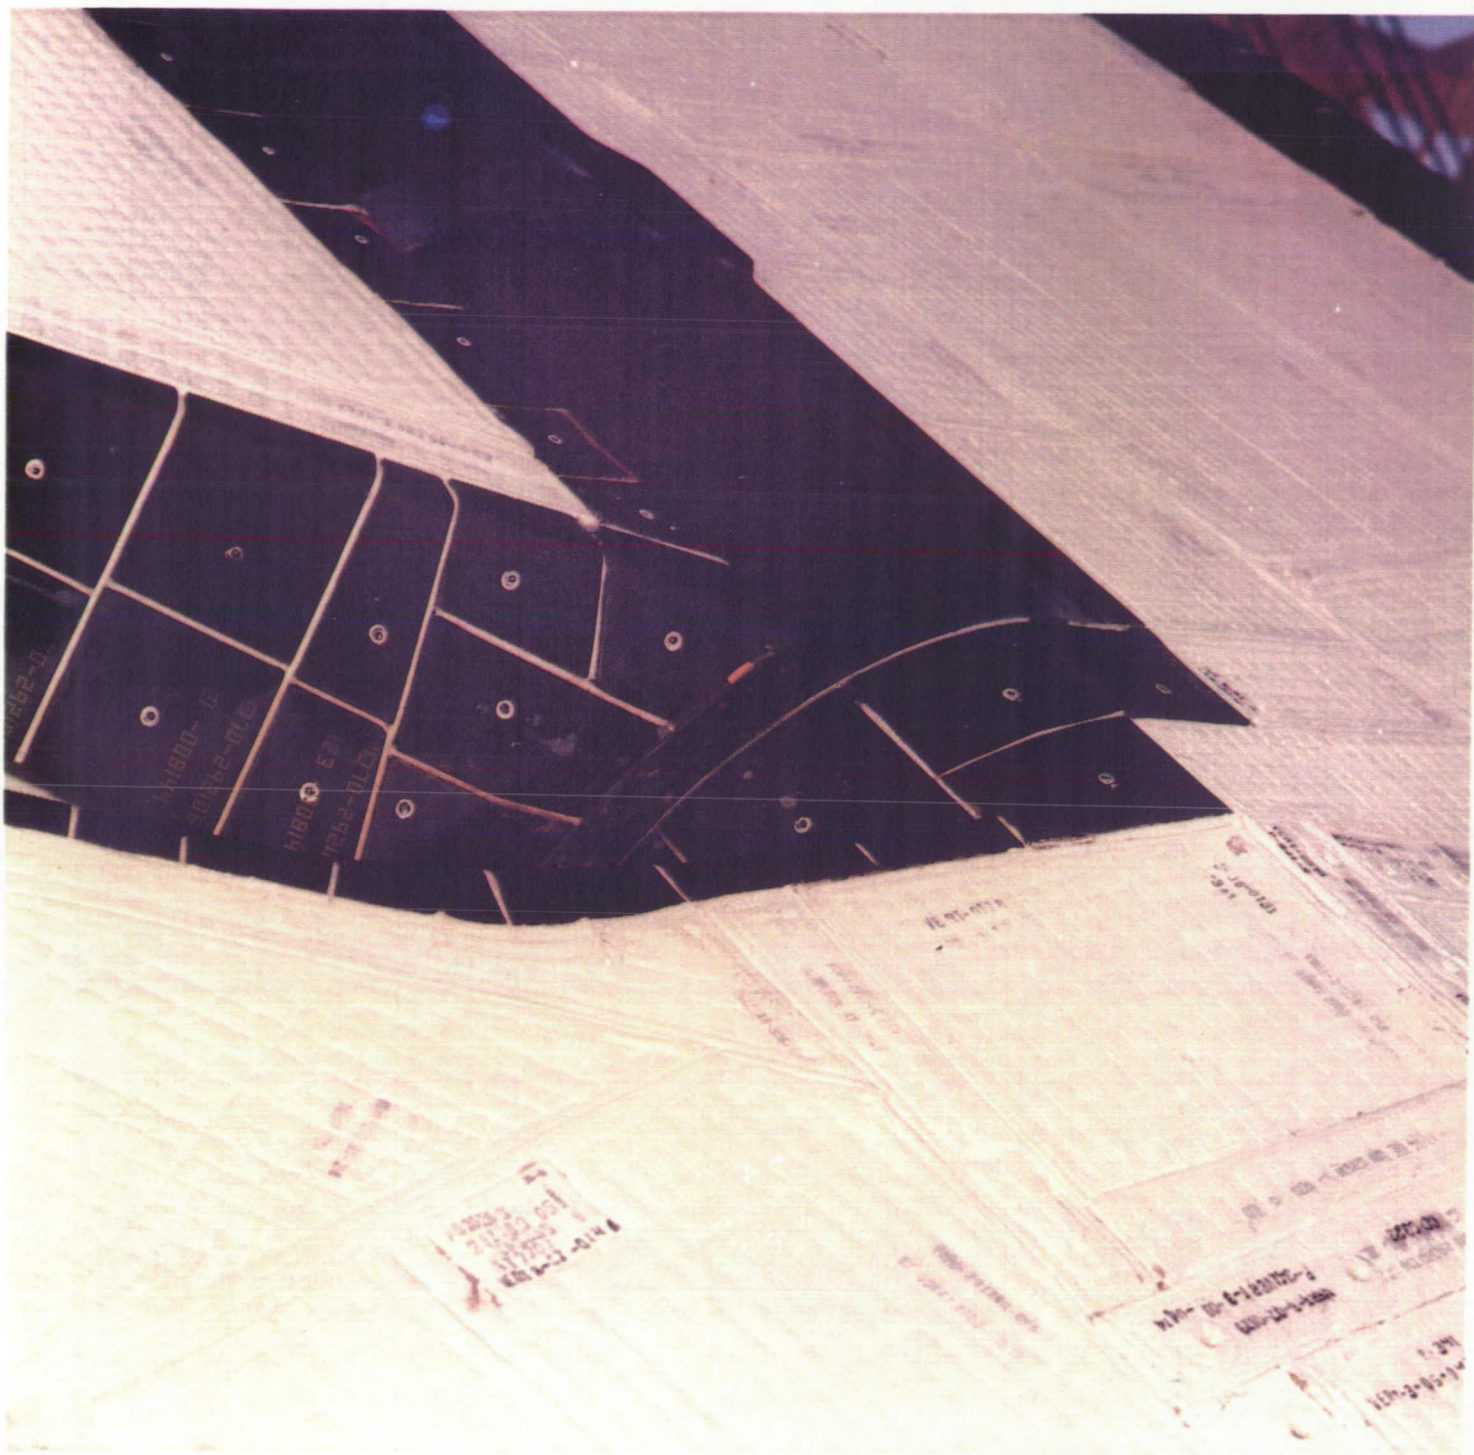
A thin orange GSE tile shim, approximately 1 inch by 1 inch in size, protruded from tiles at the bottom of the RH rudder speed brake near the hinge. GSE tile shim should not remain on the Orbiter for flight.

A thin, orange GSE tile shim, approximately 1 inch by 1 inch in size, protruded from tiles at the bottom of the RH rudder speed brake near the hinge.

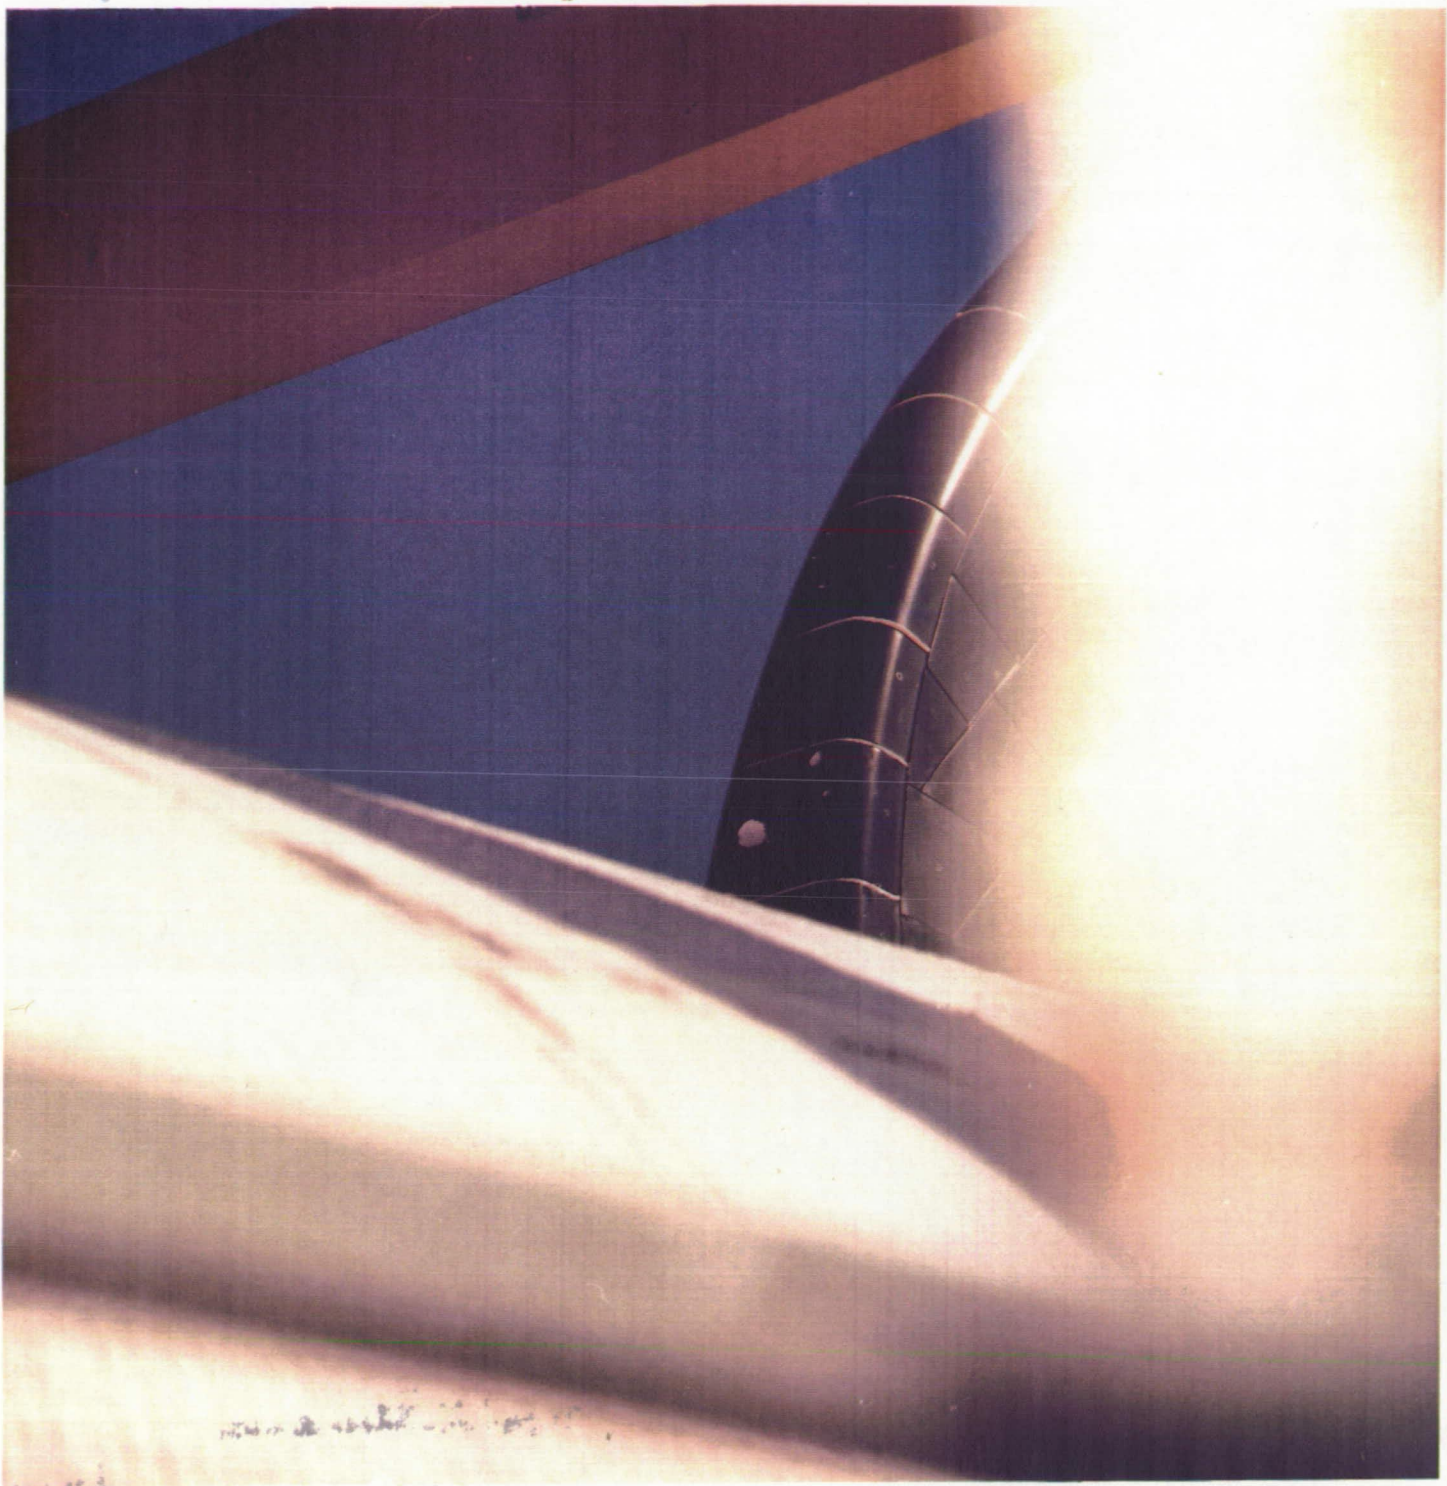
A cluster of 7 hits with one larger than one inch (3"x2"x1") was present on the leading edge of the vertical stabilizer near the root. Tile damage in this area is uncommon and may possibly be related to tile damage around the forward facing windows.

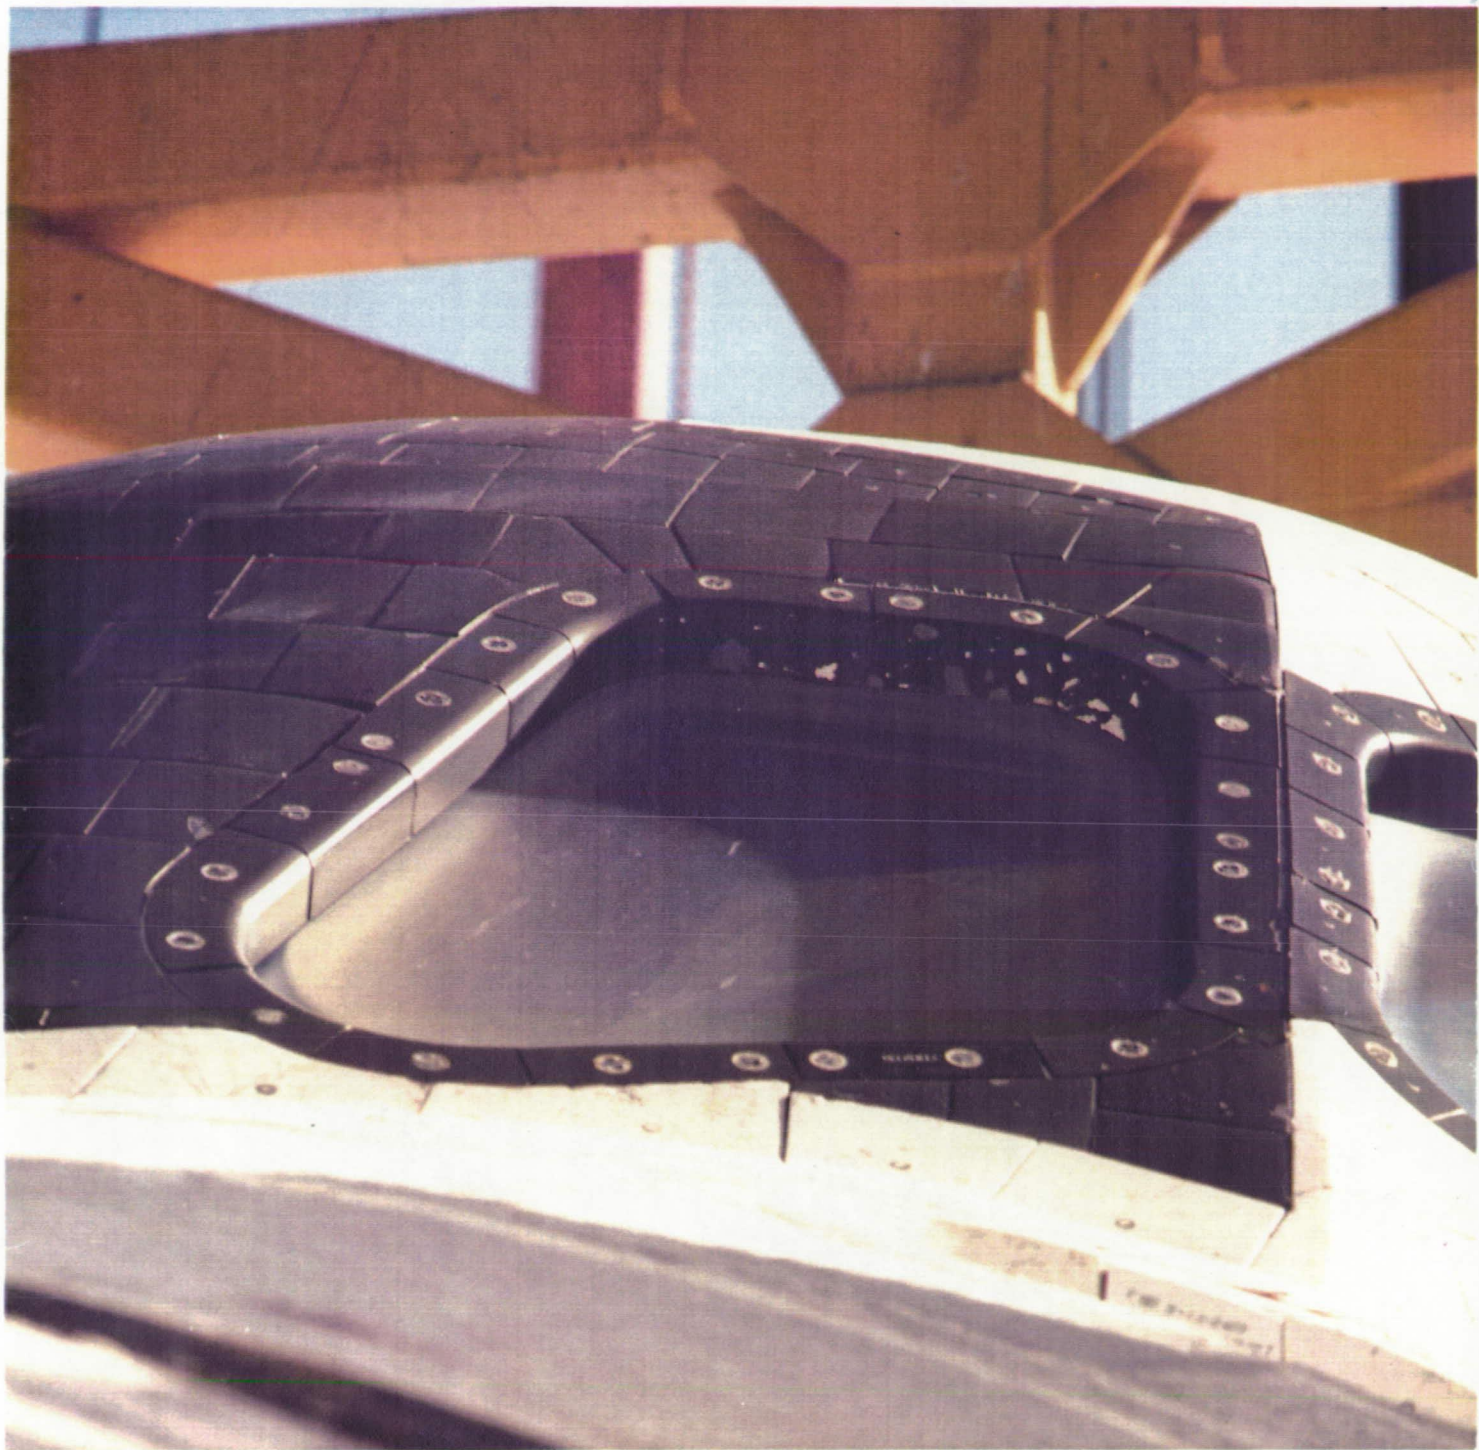
Orbiter windows #1 and #2 were lightly hazed. Window #3 exhibited moderate to heavy hazing and had numerous streaks. A greater than previously observed number of damage sites occurred on the perimeter tiles of windows #1-#6. Most of the impact sites did not exceed a depth of 1/16th inch. This damage may have been caused by the RTV used to bond paper covers to the FRCS nozzles.
